Take another look at polybutylene plumbing

by Kenny Hart, ASHI Technical Committee Member

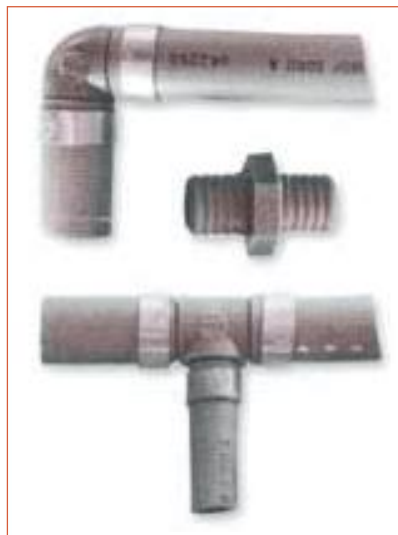
Plastic or acetal type fittings with aluminum crimp rings

Initially, aluminum crimp rings and plastic or "acetyl" fittings

Problematic aluminum rings and the acetyl fittings caused concern after the walls went up. The industries' solution was to use copper or brass fittings along with copper crimp rings. In some localities, bags of the unused parts cart-

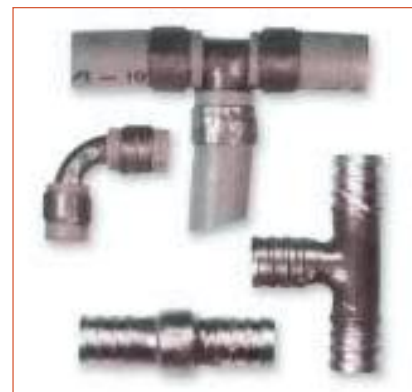
Copper fittings with copper crimp rings

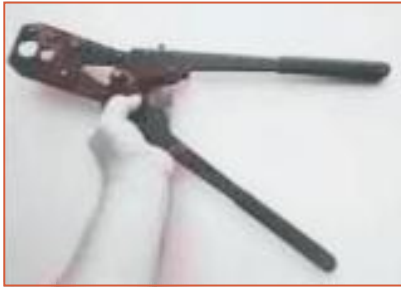
Combination crimp tool

The combination crimp tool was the next to go. Though popular when first sold, it wasn't easy to place it around the ring and still get the proper crimp action required to set the joint. The combination tool also had space limitations, and it was difficult to keep it adjusted. By the mid 80s, suppliers stopped selling it, urged plumbers to throw it away and to replace it with a single crimping tool for each pipe size. Plumbers who purchased large quantities of PB pipe sometimes received the new tools free-of charge.

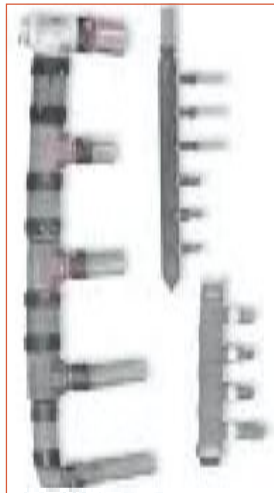
On site and factory made manifold units

“Home Run Plumbing”, involved pulling a series of 1/2" pipes from the hot and cold service locations behind each fixture to one location in or under the house.

rolls. Because the rolls of tubing could be purchased at 100 feet or more, the need to install fittings along the way on a manifold system was eliminated – a plus because fewer fittings meant fewer potential leaks.

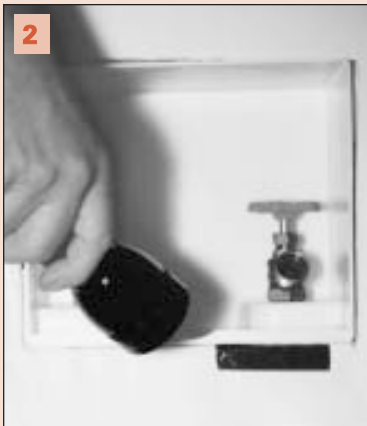
Chip or cut away a small section of wall within the frame area using the pencil mark for guidance. Check inside the wall with a flashlight for the gray pipe and metal ring.

On outer walls it may be necessary to pull the pipe wrap from around the pipe. This can usually be done with a screwdriver or other flat edge.

After your check re-install the frame.

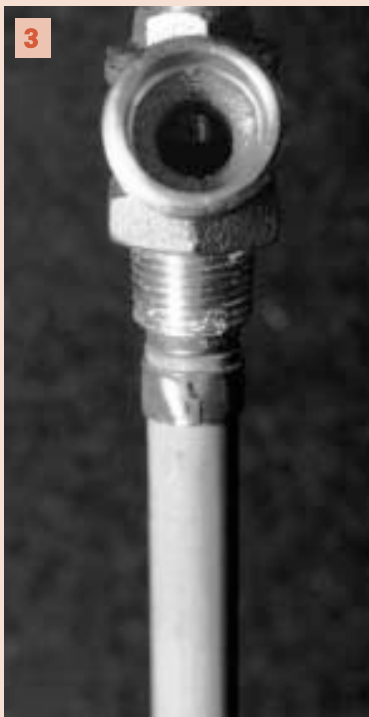
The removed valve at the left is typical of what you might see, but in some cases a compression fitting might be observed.

When inspecting a slab home, where there is no PB visible below sinks, behind water heaters, under jetted tubs or in the attic, I recommend trying to check the washing machine utility box. Though some inspectors check at the water meter, this doesn't necessarily determine if the problematic pipe is in the wall. It may indicate the possibility that the yard service line is polybutylene. A common practice for plumbers was to connect the polybutylene piping directly to the service valves (boiler drains), thread the pipe through the 1/2" valve hole at the washing machine box and use a lock nut to secure the valve at to the box.
